# ZU1 SYSTEM BLOCK DIAGRAM

**PROJECT : ZU1**  
**Quanta Computer Inc.**

| | <b>Block Diagram</b> | 3B |

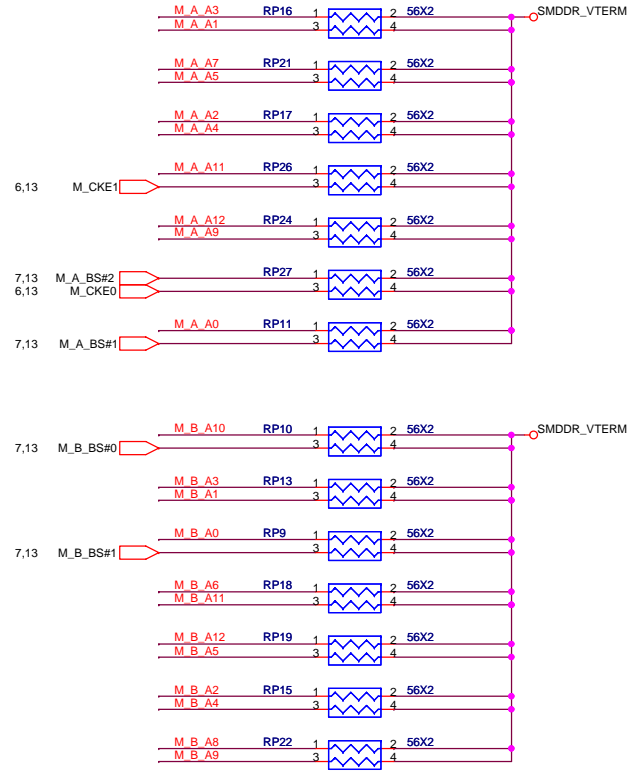
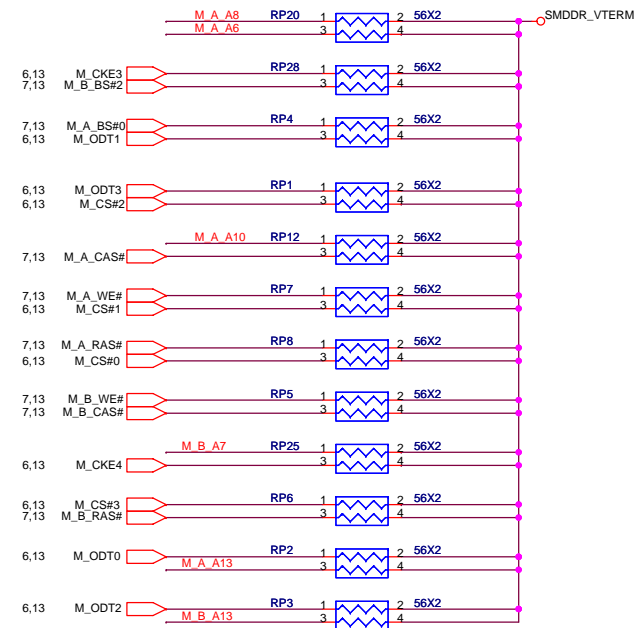
INTEL FAE (08/17)  
 ADD MA14 FOR DUAL LAYERS RAM

Place one cap close to every 2 pull-up resistor terminated to SMDDR\_VTERM

Diagram showing the addition of resistors R144 and R135 (56.4) for dual layers RAM, connected to the SMDDR\_VTERM pin. The signals M\_A\_A14 and M\_B\_A14 are shown.

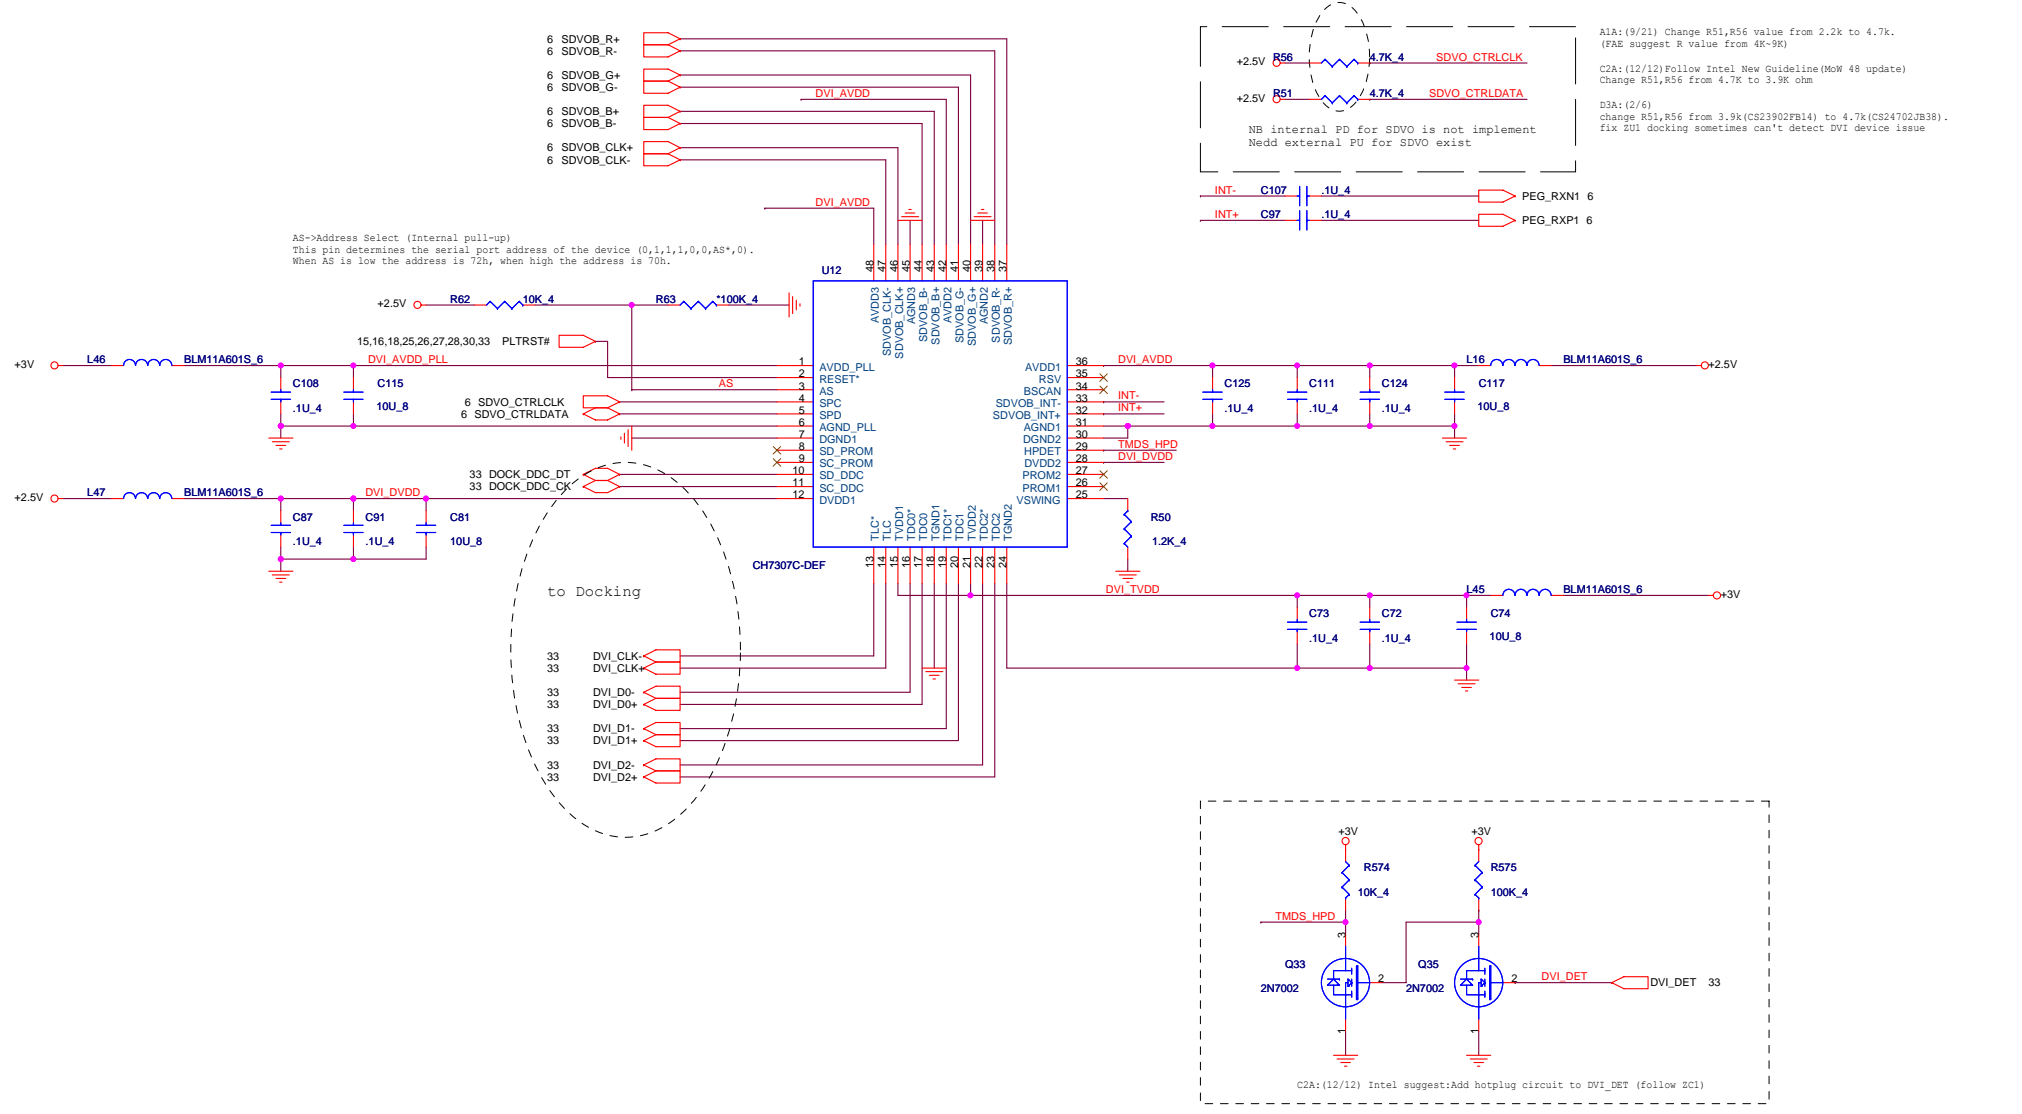
AS->Address Select (Internal pull-up)  
 This pin determines the serial port address of the device (0,1,1,1,0,0,AS\*,0).  
 When AS is low the address is 72h, when high the address is 70h.

A1A: (9/21) Change R51,R56 value from 2.2k to 4.7k.  
 (FAE suggest R value from 4K-9K)  
 C2A: (12/12) Follow Intel New Guideline (MoW 48 update)  
 Change R51,R56 from 4.7k to 3.9k ohm  
 D3A: (2/6)  
 change R51,R56 from 3.9k(CS23902FB14) to 4.7k(CS24702JB38).  
 fix ZUI docking sometimes can't detect DVI device issue

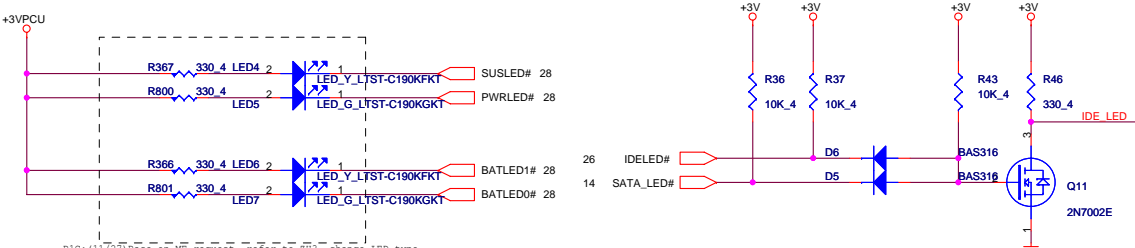
**LED**

B1C: (11/27) Base on ME request, refer to ZH3, change LED type  
 B1C: (11/28) Base on ME request, change LED type  
 D3A: (1/24) Base on SMT-ME request, change LED type to 2 in 1  
 D3A: (3/16) Change LED2, LED3 type base on ME request, Add R800, R801  
 E3A: (3/30) ESD issue, change LED type (follow B stage)

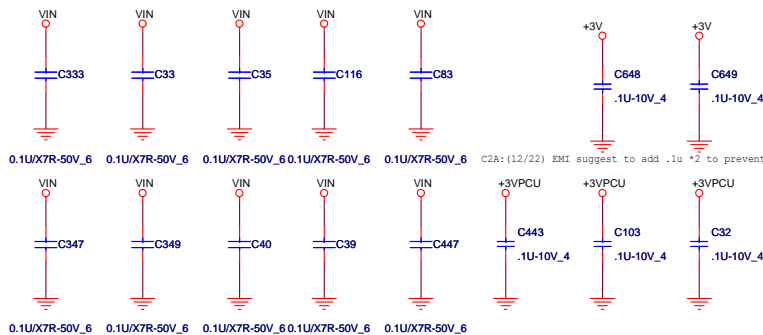
## EMI Cap

A1A: (10/19) EMI suggest : Add the VIN power shape bypass cap 0.1uF x 10pcs  
Add the +3VPCU power traces bypass cap 0.1uF x 3pcs

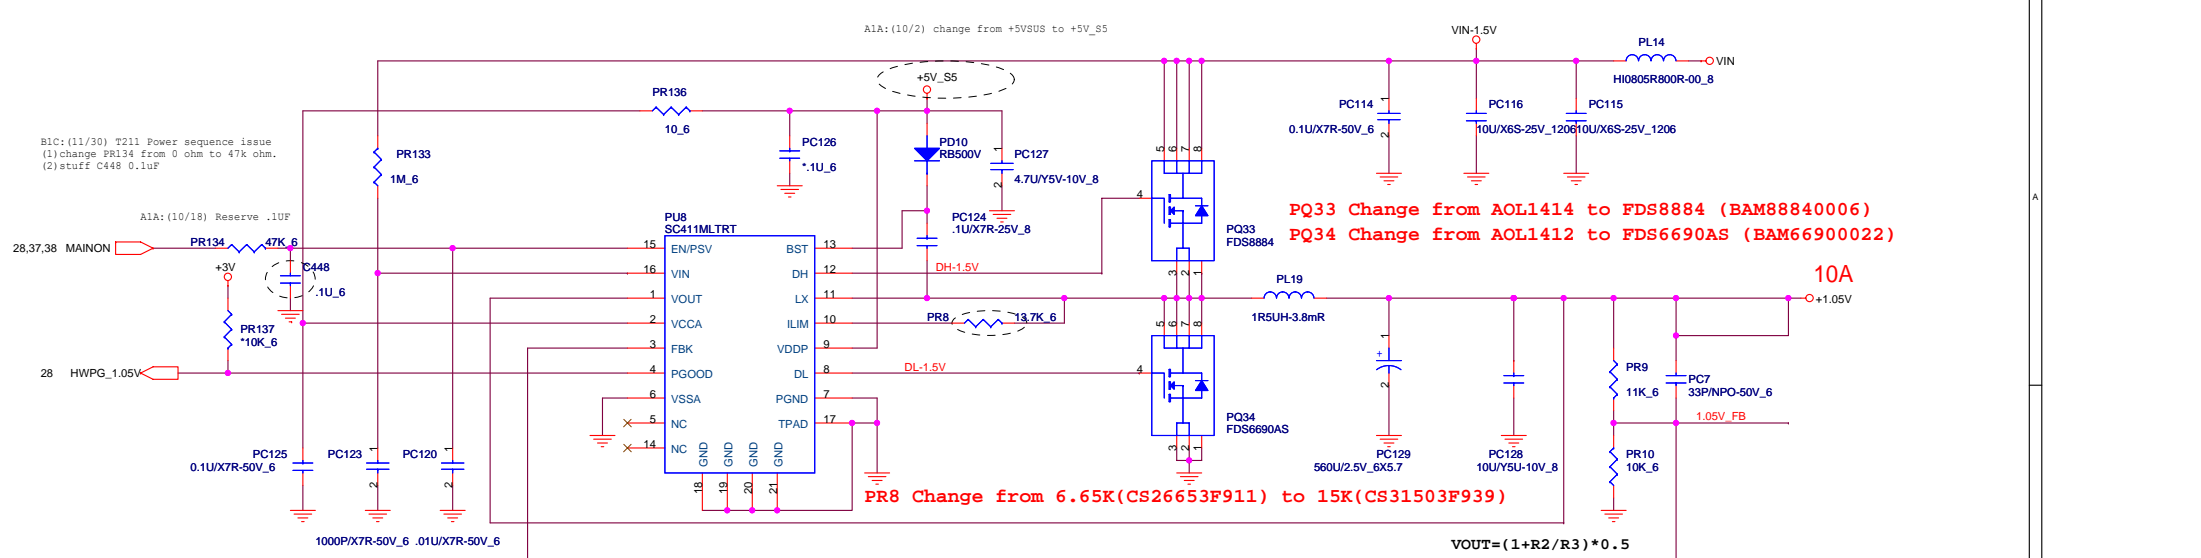
| | | <b>VTT 1.05V (SC411)</b> | | 3B |

B1C: (11/30) T211 Power sequence issue  
 (1) change PR134 from 0 ohm to 47k ohm.  
 (2) stuff C448 0.1uF

**PQ33 Change from AOL1414 to FDS8884 (BAM88840006)**  
**PQ34 Change from AOL1412 to FDS6690AS (BAM66900022)**

**PR8 Change from 6.65K(CS26653F911) to 15K(CS31503F939)**

**PR9 Change from 20K to 11K (CS31103F926)**

B1C: (11/29) Change PR8 from 20K(CS32003F933) to 6.65K ohm (CS26653F911)

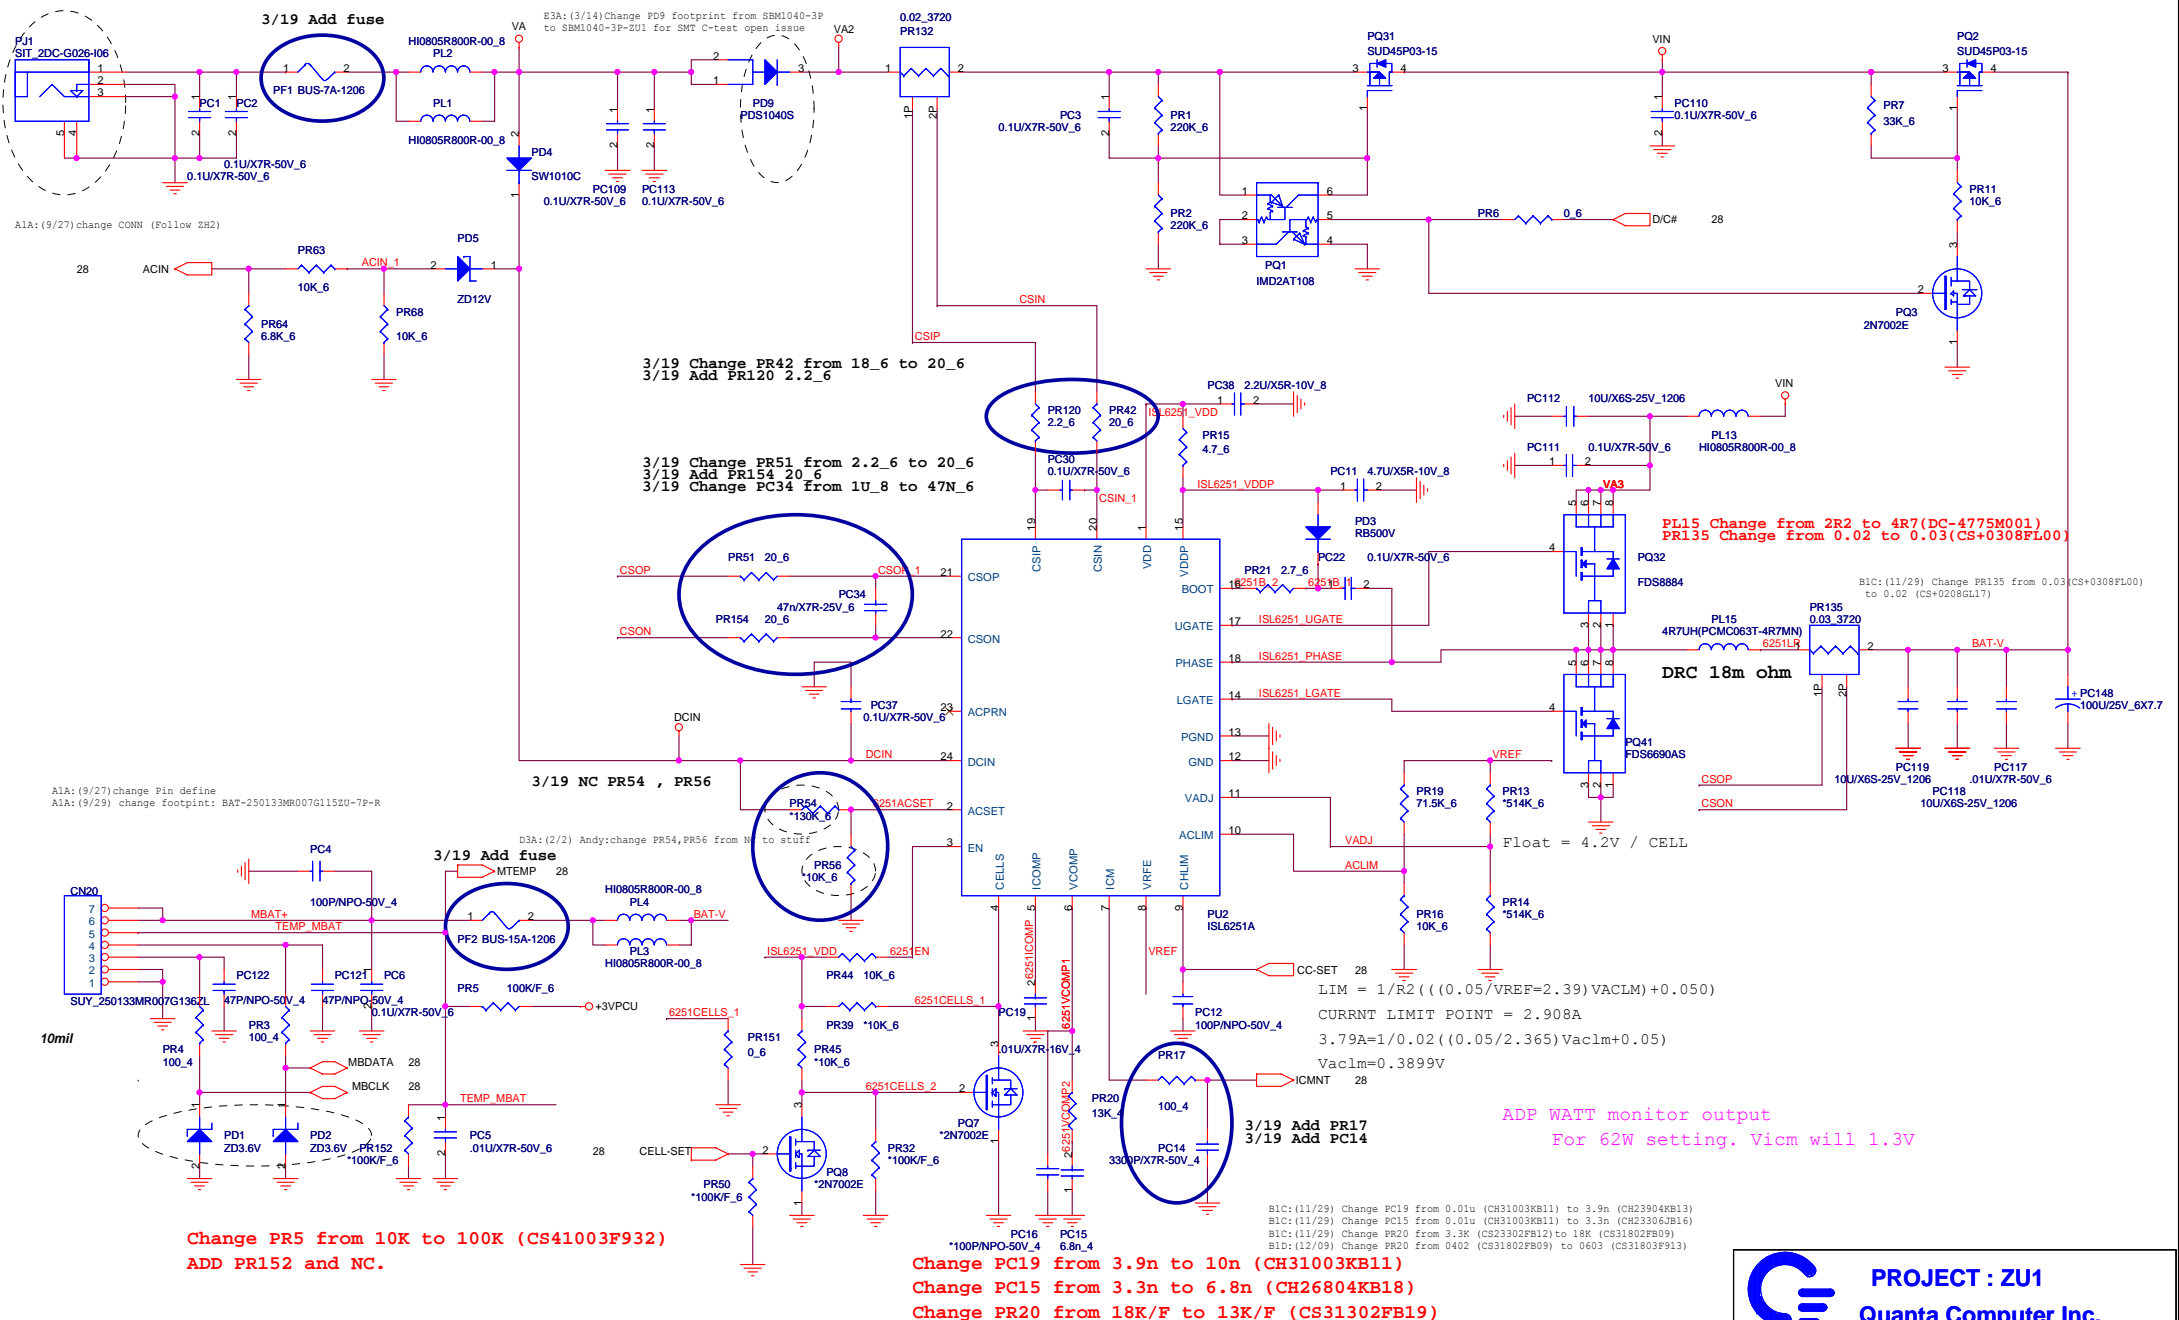
| | <b>Charger (ISL6251)</b> | 3B |

3/19 Add fuse

ADP WATT monitor output  
For 62W setting. Vicm will 1.3V

CELL-SET = Hi ----> Cells = VDD ---->4S  
CELL-SET = Low ----> Cells = GND ---->3S
